Object Documentation: Mamaroneck Passive House in Mamaroneck

Projekt-ID: 2629

Project Designer: Andreas M. Benzing / a.m.Benzing architects pllc
80 Eight Avenue, Suite 1503, New York NY 10011
(T) 212.265.3424, contact@andreasbenzing.com
<http://www.andreasbenzing.com>

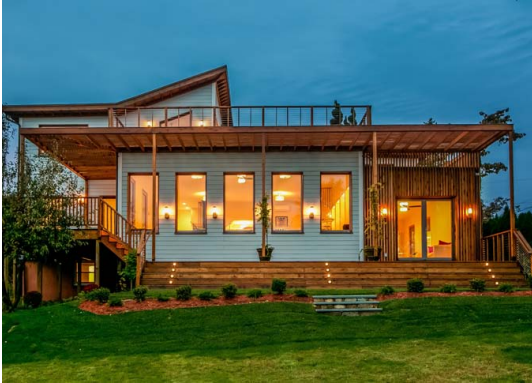
South Elevation

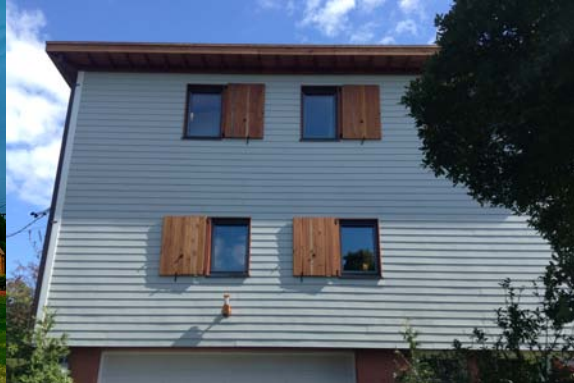
West Elevation

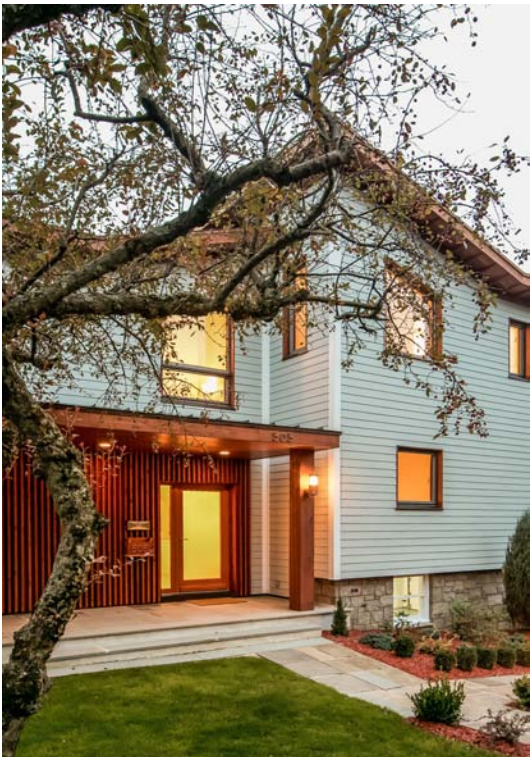
North Elevation

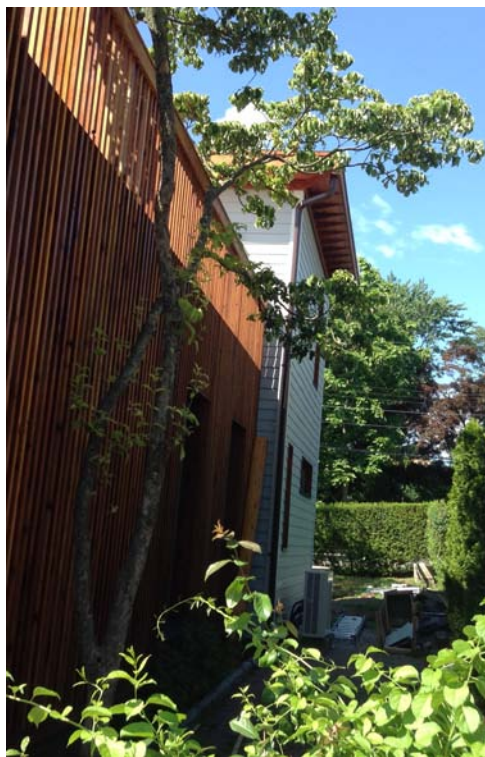
East Elevation

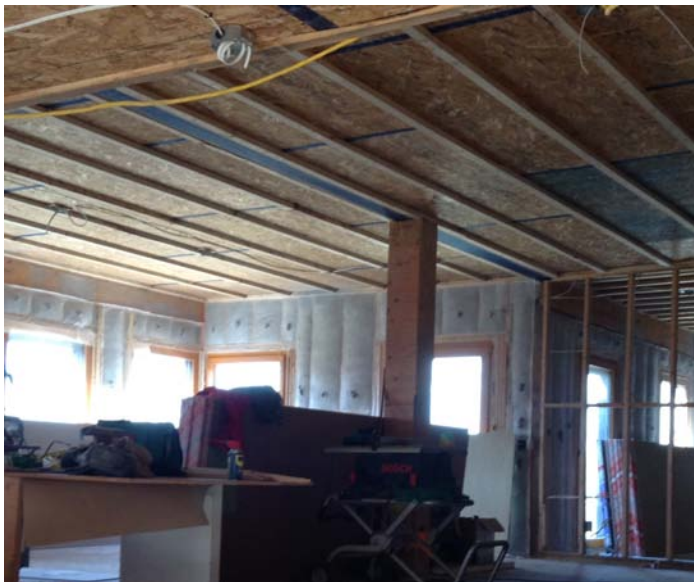
Picture above: Taped air tight layer of interior OSB roof sheathing.

Explanation: The wall air tight layer is composed of a taped OSB sheathing with connects to the taped plywood subfloor and a taped OSB interior roof sheathing.

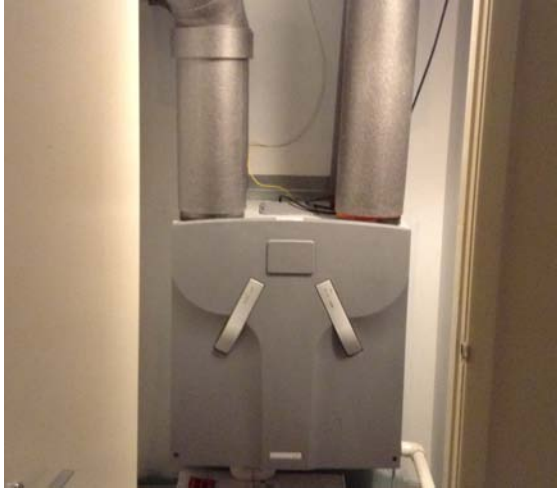
Picture above: Zehnder ComfoAir 550

Explanation: Effective heat recovery: 70.9%, Electric Efficiency: 0.31 Wh/m³. The ERV is located inside the thermal envelop in the basement. An ERV was specified because of the humidity in the summer period.

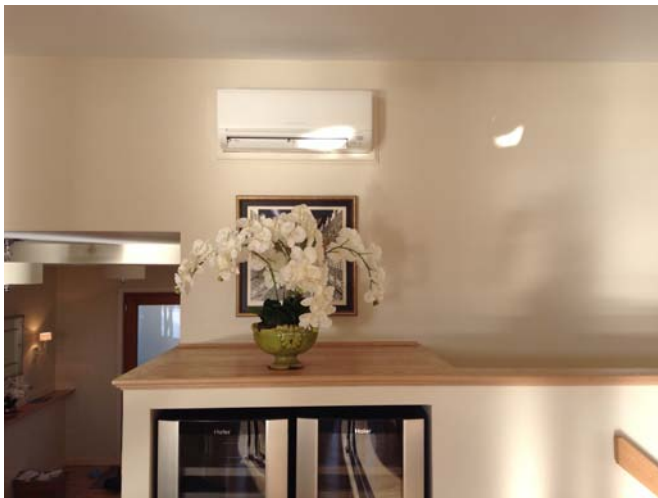
Picture above: Picture of wall hung interior unit

Explanation: The heating and cooling system was specified as a ductless Mitsubishi mini split system. The exterior condenser unit is located on the east side which is not visible. The interior wall hung units are located throughout the building. In addition there is a natural gas stove from Jotul for ambient heat and for resiliency in case of a power outage. The stove has 20,000 Btu/hr heat output and is located in the center of the first floor next to the stairs, the heat is distributed by natural convection and radiation, in addition a small fan integrated into the stove can boost heat distribution. The DHW system is a 80 gal HP-tank from Stiebel Eltron which is located in the basement.
