Passive House Case Study

Build Back Better: Marshall Fire Rebuild

Boulder, CO

Rebuild from Existing Foundation

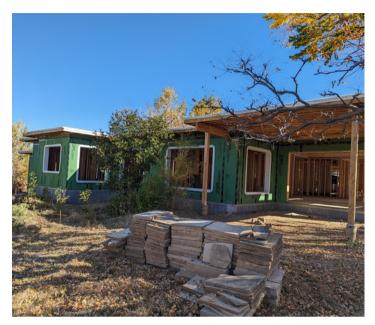
This large ranch home provides seamless indoor/outdoor living with large Zola sliders connecting the kitchen/living area, and the Library room to southern and western patios.

Large Zola windows frame panoramic Rocky Mountain views. Exterior zip systems will be covered with a rain screen for moisture management and clad with a variety of Stone, Stucco, and Cementitious siding.

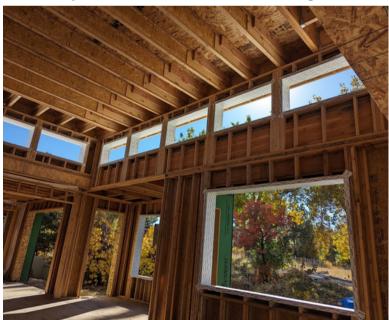
The kitchen features a large clerestory with lots of light. The high windows are operational powered Zola windows. The Southern sliding door opens onto the patio with an Herb Garden and a grape vine covered pergola. Exterior finishes and landscaping will create a fire defensible space around the home.
