Passive House Case Study

Build Back Better: Marshall Fire Rebuild

Boulder, CO

Rebuild from Existing Foundation

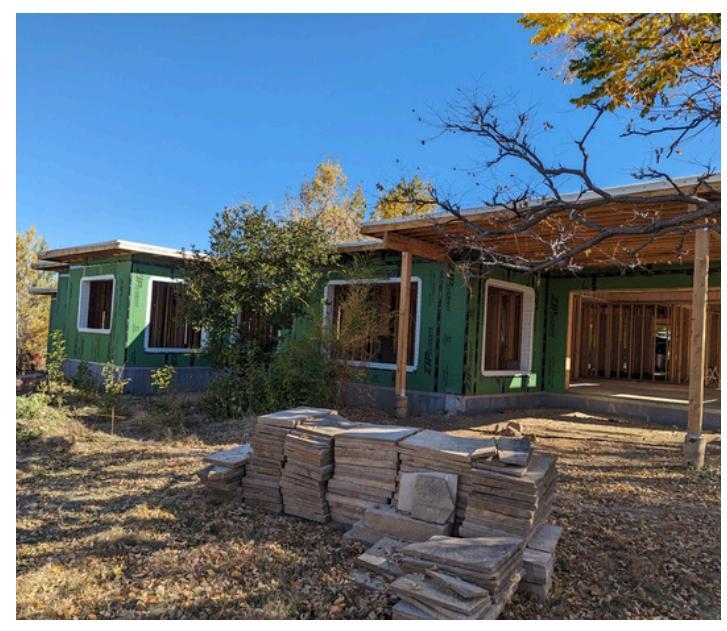
This large ranch home provides seamless indoor/outdoor living with large Zola sliders connecting the kitchen/living area, and the Library room to southern and western patios.

Large Zola windows frame panoramic Rocky Mountain views. Exterior zip systems will be covered with a rain screen for moisture management and clad with a variety of Stone, Stucco, and Cementitious siding.

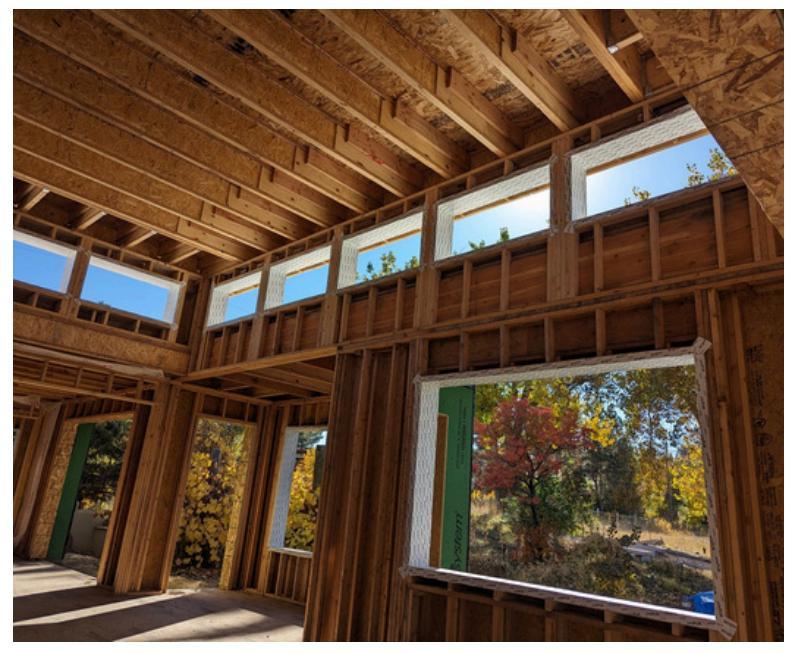
The kitchen features a large clerestory with lots of light. The high windows are operational powered Zola windows. The Southern sliding door opens onto the patio with an Herb Garden and a grape vine covered pergola. Exterior finishes and landscaping will create a fire defensible space around the home.

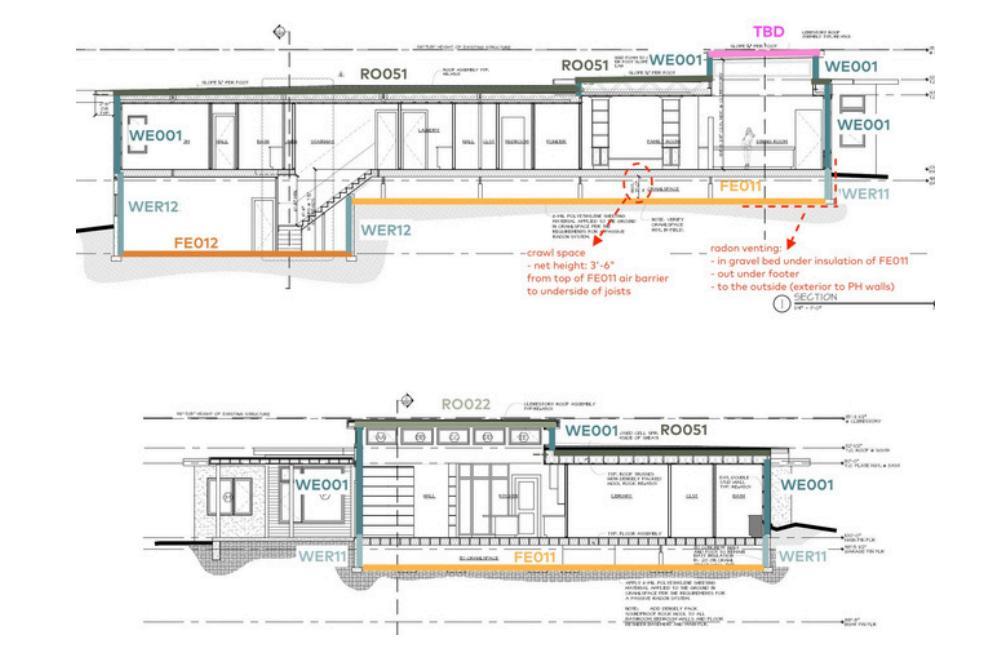
The entire home will be encapsulated and sealed to below 1.0 ACH50. The main level is a full ranch, but there is an attached Accessory Dwelling Unit, which is a basement garden level space. It is accessible from its own entrance outside, or via stairs inside.

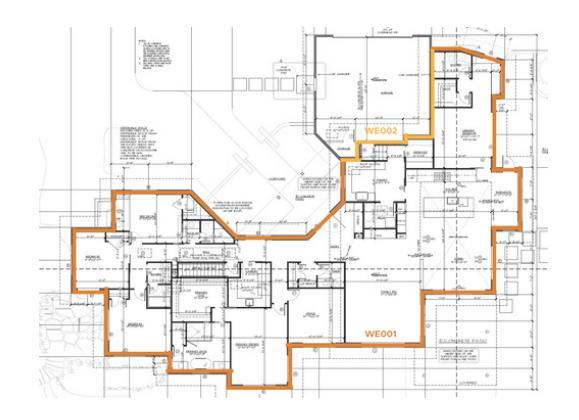
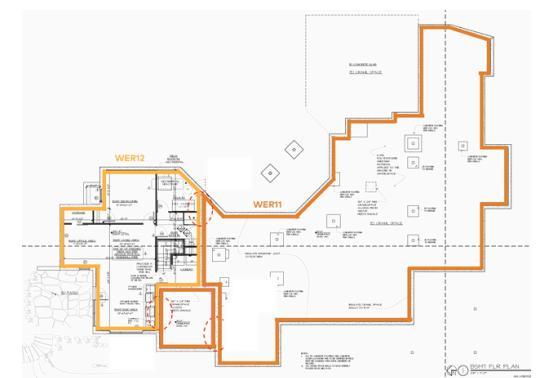
The home reuses the existing foundation that was not damaged during the fire. It was modernized by "capping" the foundation to ensure proper damp proofing and frost protection for the footer. The entire crawl space was then retrofitted with 8" of EPS foam and 20mil vapor barrier. Steel elements that were potential thermal bridges were engineered out in favor of Laminated Veneer Lumber and Glu-Lam Beams.
